REPORT DOCUMENTATION PAGE		READ INSTRUCTIONS BEFORE COMPLETING FORM
1. REPORT NUMBER	2. GOVT ACCESSION NO.	3. RECIPIENT'S CATALOG NUMBER
	AD-A091278	
4. TITLE (and Subtitle) Phase I Inspection Report Fresh Air Fund Dam Site I Lower Hudson River Basin, Dutchess County, NY Inventory No. 288		5. TYPE OF REPORT & PERIOD COVERED Phase I Inspection Report National Dam Safety Program

PHASE I INSPECTION REPORT
NATIONAL DAM SAFETY PROGRAM
FRESH AIR FUND DAM I.D. No. NY 288
SITE 1
DEC #212D-1528 LOWER HUDSON RIVER BASIN
DUTCHESS COUNTY, NEW YORK

Name of Dam Fresh Air Fund Dam #1 (Duck Lake)
Fed. I.D. # NT 288 DEC Dam No. 212 D -1528
River Basin Lower Hudson
Location: Town Fishkill County Dutchess
Stream Name Unnamed tributary of Fishkill Creek
Tributary of Hudson River
Latitude (N) 41° 30.5' Longitude (W) 73° 51.5'
Type of Dam Homogeneous Earth
Hazard Category "C" High
Date(s) of Inspection July 9, 1980
Weather Conditions Partly Cloudy; Temp 70's
Reservoir Level at Time of Inspection Approximately 3.0' above crest

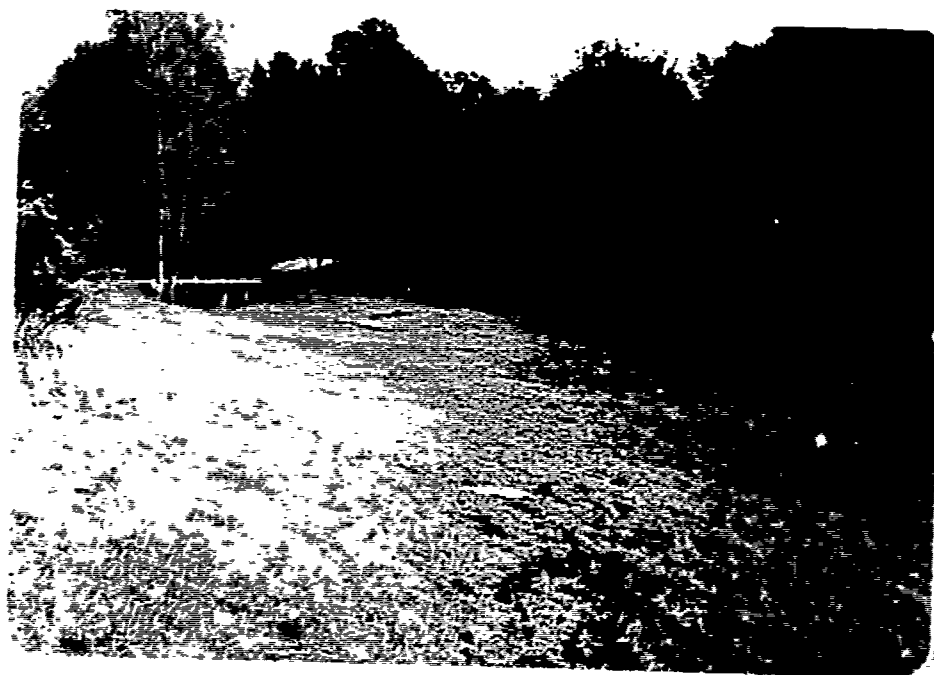
No signs of major distress were observed in connection with the earth embankment. No evidence of misalignment, sloughing, subsidence, depressions, or surface cracking were observed on the embankment slopes or crest. (See Photos #1 & 4) The upstream slope at normal pool level was riprapped. (See Photo #4) Extensive vegetation was observed along the upstream slope, extending to the crest, at the left abutment contact, and at the downstream toe of the embankment. (See Photos #1, 4 & 5) Vegetation was also noted in the vicinity of Service Spillway intake (Photo #2) and on the banks of the auxiliary spillway adjacent to the access bridge. (See Photo #3)

The auxiliary spillway appears to be in good condition, with the exception of the trees adjacent to the access bridge.

Photo #3
Auxiliary Spillway

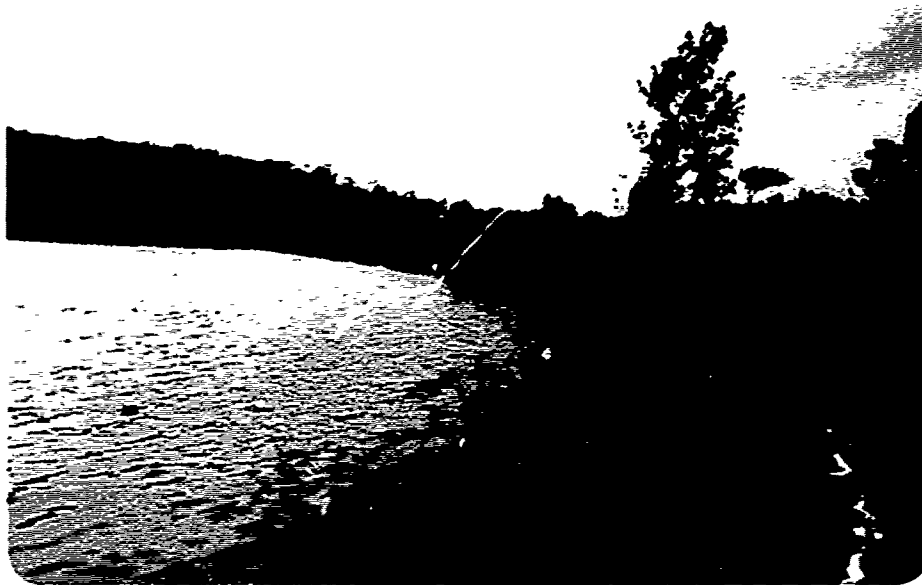
Photo #4
Upstream Face of Embankment
